INSTALLATION RESTORATION PROGRAM PHASE 2
CONFIRMATION/QUANTIFICATION STAGE 1 BERGSTROM AFB TEXAS
VOLUME 1(U) RADIAN CORP AUSTIN TX 27 APR 87

BERGSTROM AIR FORCE BASE, TEXAS 78743

April 1987

Final Report, March 1984 - August 1986

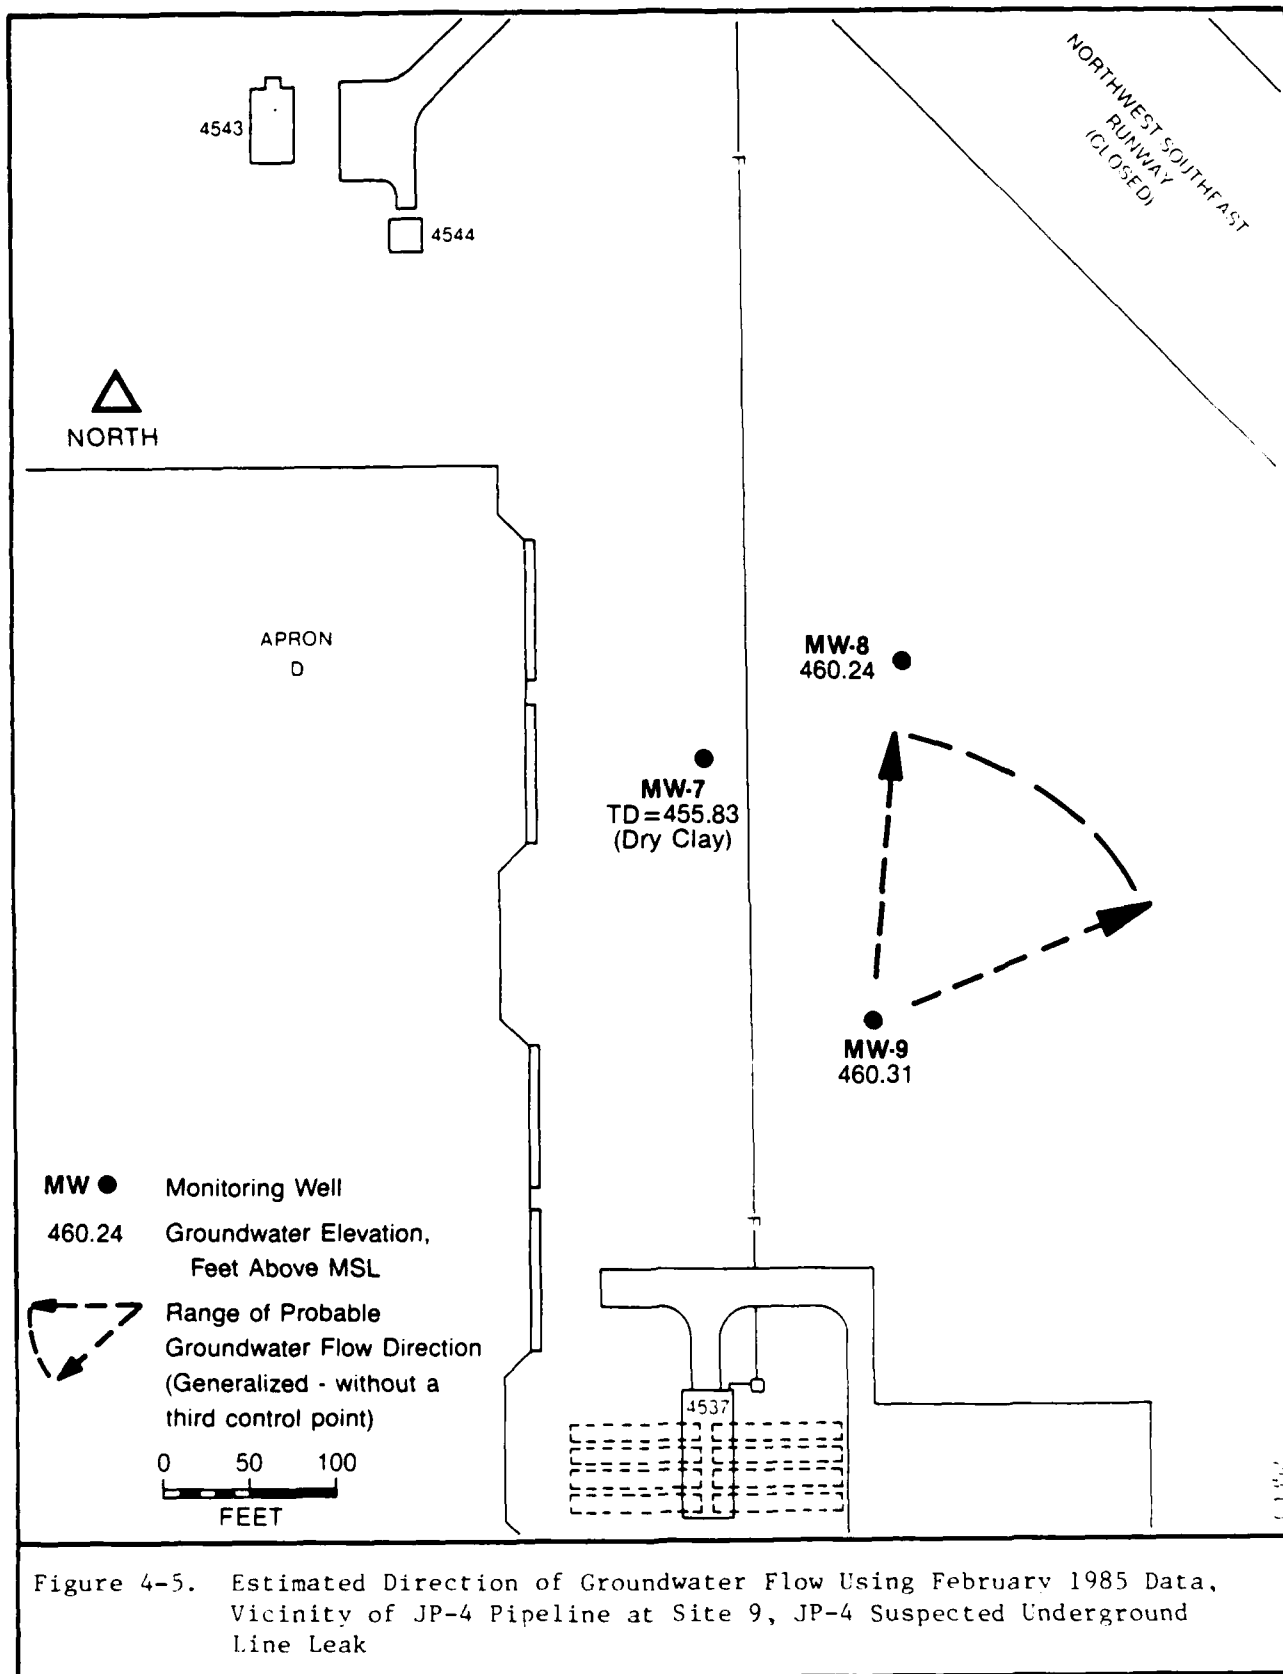
Groundwater was found in the sands and/or gravels that overlay the Taylor Formation at Monitoring Wells 8 and 9. Monitoring Well 7 was drilled completely through clay to a depth of 35 feet and was dry. The composition and shape of the deposits at monitoring wells 8 and 9 indicate the existence of an old river channel. This channel is a potential pathway for the migration of fuel. The direction of groundwater flow cannot be accurately determined with only two groundwater elevation points; however, based on existing data (Figure 4-5), the flow should move in a general direction from MW-9 towards MW-8 or a southerly to northerly direction. Normally, three groundwater level elevations are needed to accurately define a flow direction. Although only two control points were available (i.e., MW-8 and 9) the third point (M-7) had dry conditions well below (i.e., approximately 15 feet) the water levels at MW-8 and 9. The water level at MW-9 was higher than at MW-8.

which indicates a groundwater gradient towards MW-8. But without a third control point with a water level, the flow direction can only be generalized as shown in Figure 4-5. Chemical analysis performed on groundwater samples from these monitoring wells showed (MW-8 and MW-9) no compounds detected using EPA Method 602. Precipitation occurred prior to groundwater sampling, and water filled the utility vault next to the low-point drain.

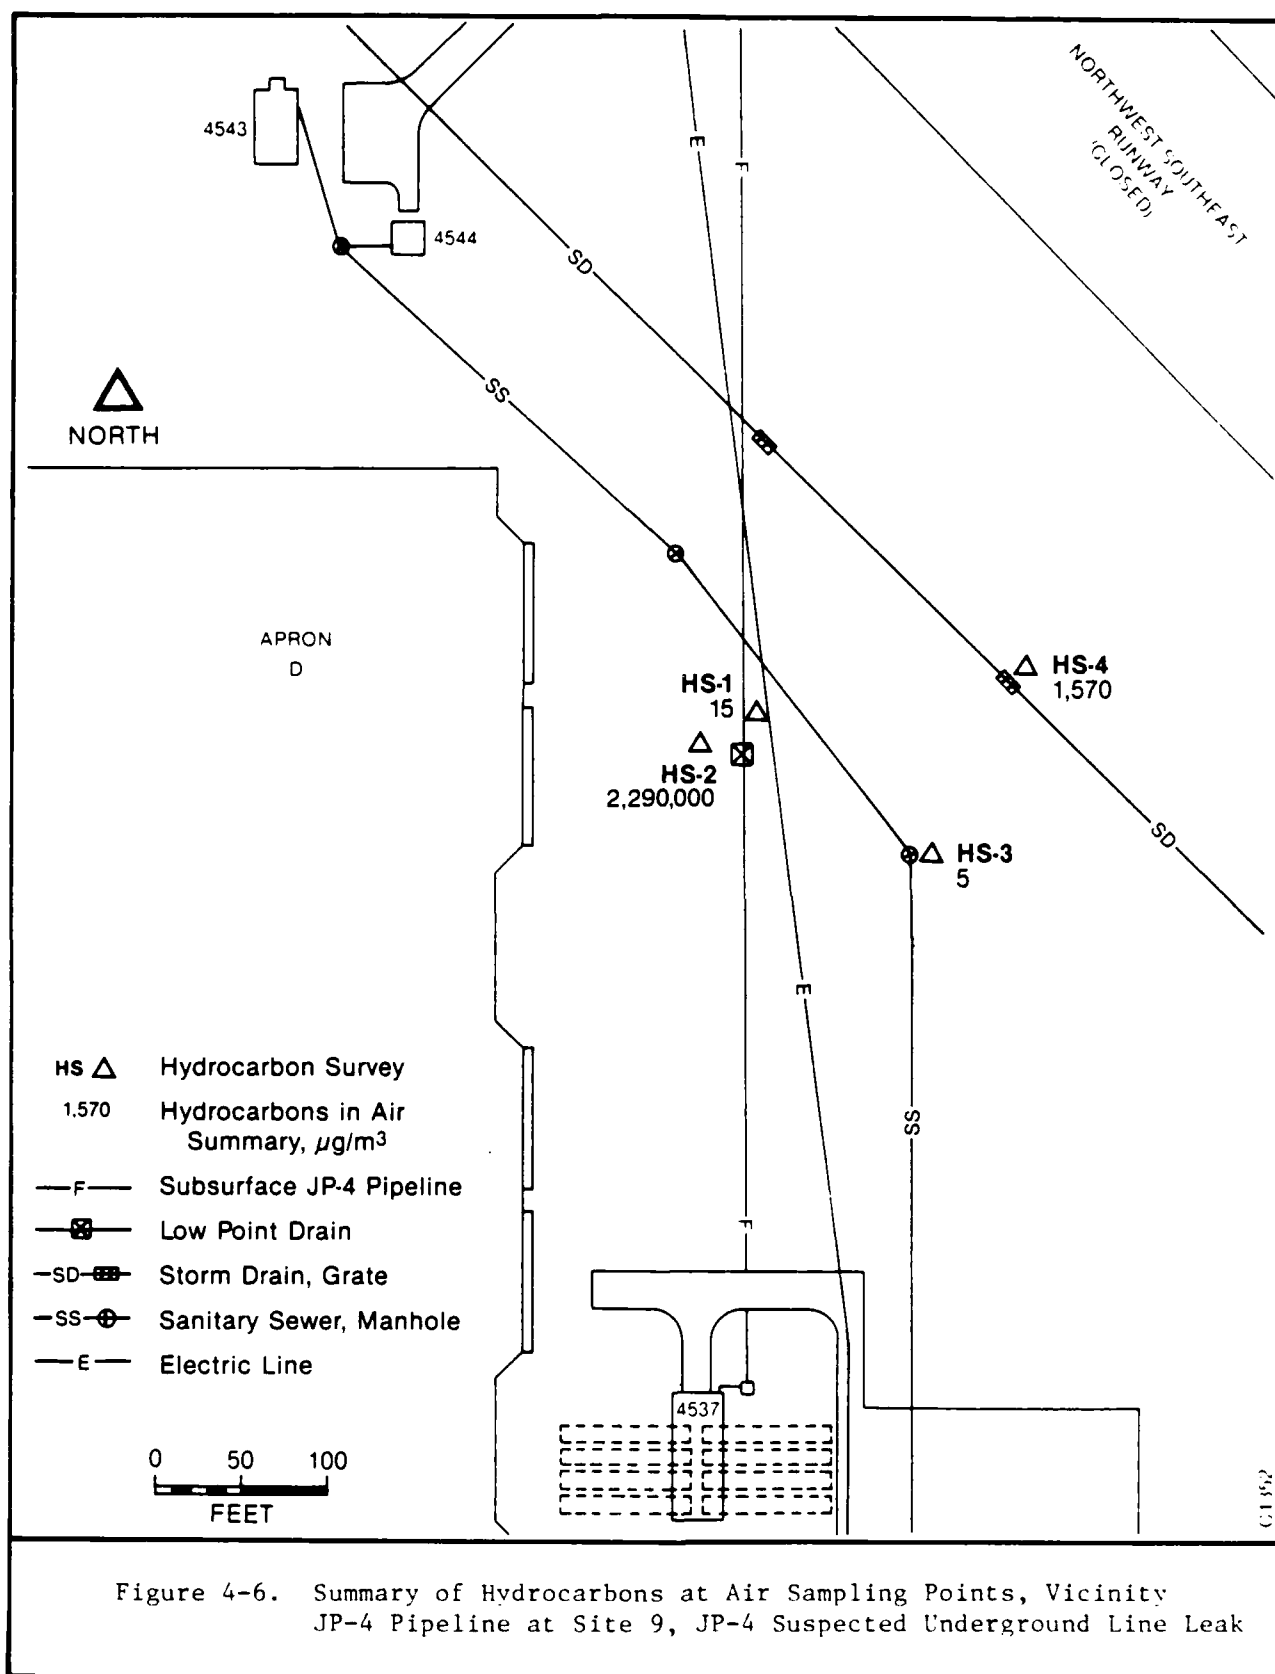
Figure 4-6. Summary of Hydrocarbons at Air Sampling Points, Vicinity JP-4 Pipeline at Site 9, JP-4 Suspected Underground Line Leak

Air samples were taken at the following four locations: an electrical utility vault (HS-1), Monitoring Well 7 (HS-2), a sanitary sewer (HS-3), and a storm drain (HS-4). These samples were taken to detect the presence of fuel vapors and are summarized (from data in Table 4-16) in Figure 4-6. Of the four locations, only two showed concentrations of compounds typical of JP-4 fuel. Sample HS-2, taken from location MW-7, has a large number of these compounds; whereas sample HS-4, taken from a storm drain, shows only a few components. It is probable that the vapors in the storm drain originated from compounds introduced from the flightline rather than directly from the pipeline. Additionally, the low hydrocarbon value at HS-1 may have been affected by local precipitation that filled the electrical vault with water within several feet of the ground surface. This may have flushed any hydrocarbons that were present at HS-1.

The investigation indicates that a periodic leak in the JP-4 pipeline did exist, but the contamination caused by the leak is fairly well contained in the small area around the low-point drain box.

Site(s)	Rationale	Summary of Recommended Actions
Site 9. JP-4 Sus- pected Underground Line Leak	Confirmation of fuel leak. Observations by base per- sonnel of fuel in utility vaults.	Conduct groundwater sam- pling and possibly in- stall another well, de- pending on analytical results. Collect another air sample from a utility vault.
